## 1 Basic equipment requirements

## 2 Ecoplus-Bluetooth-PCB (EBS&EE-PN:10240808)

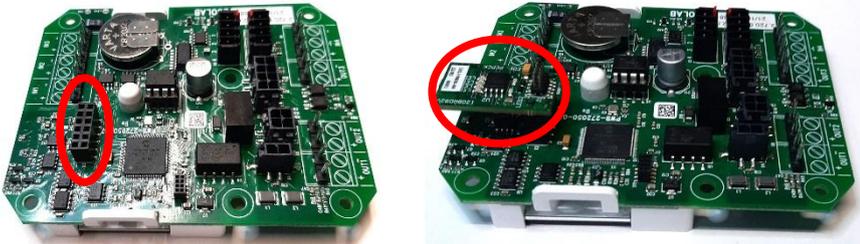
### 2.1 Mounting

**Please note:** A wrong mounting can damage both electronic boards.

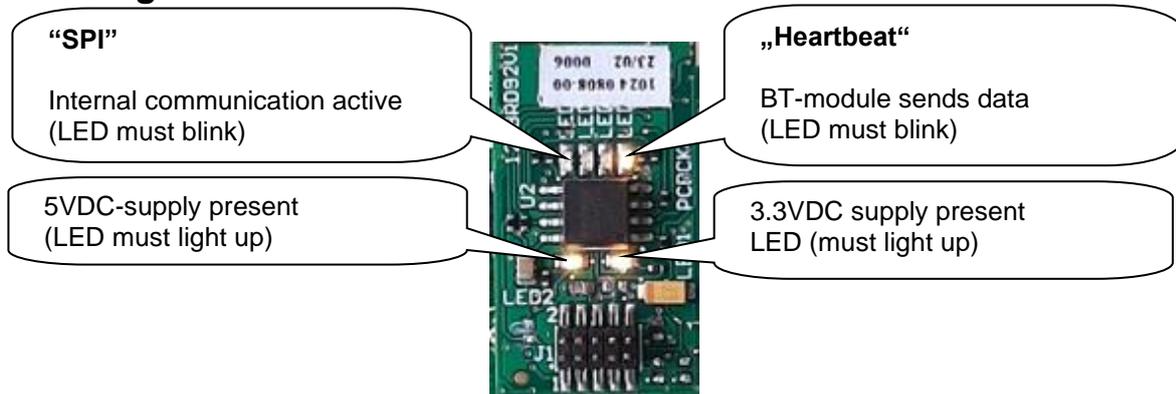
### 2.2 Meaning of LED's

Fault description	Cause	Remedy
5V-LED is off (LED2)	(No supply from WWC-PCB) BT-PCB not mounted correct. WWC-PCB not on power. WWC-PCB defective.	Mount BT-PCB in the right way Switch on WWC-PCB Change WWC-PCB
3.3VDC LED is off but 5VDC is on	BT-PCB defective	Change BT-PCB
No "heartbeat"	BT-PCB defective	Change BT-PCB
"communication LED" don't blink	WWC-PCB has wrong software	Install SW V3.00 or higher

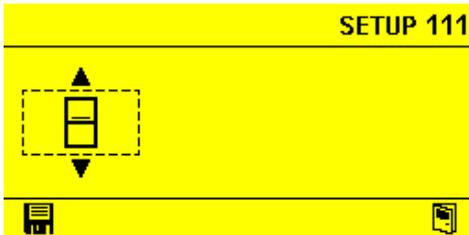
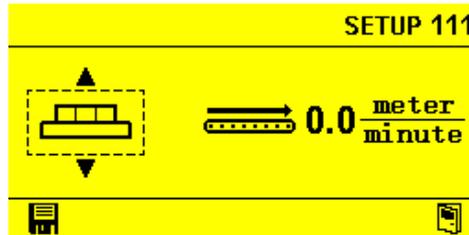
From V3.00d a “belt-speed” has been added in the DW-setup display 111.  
So, now it is mandatory to set up the right DW-type (Single tank or conveyor).

With this “belt speed” parameter the system creates “Rack counts”  
Internally we calculate with a Rack-size of 0.5m.

E. G. The belt speed is 1m/min → we count 2 racks per minute

The indicator for the Belt-On is the EN-WASH signal

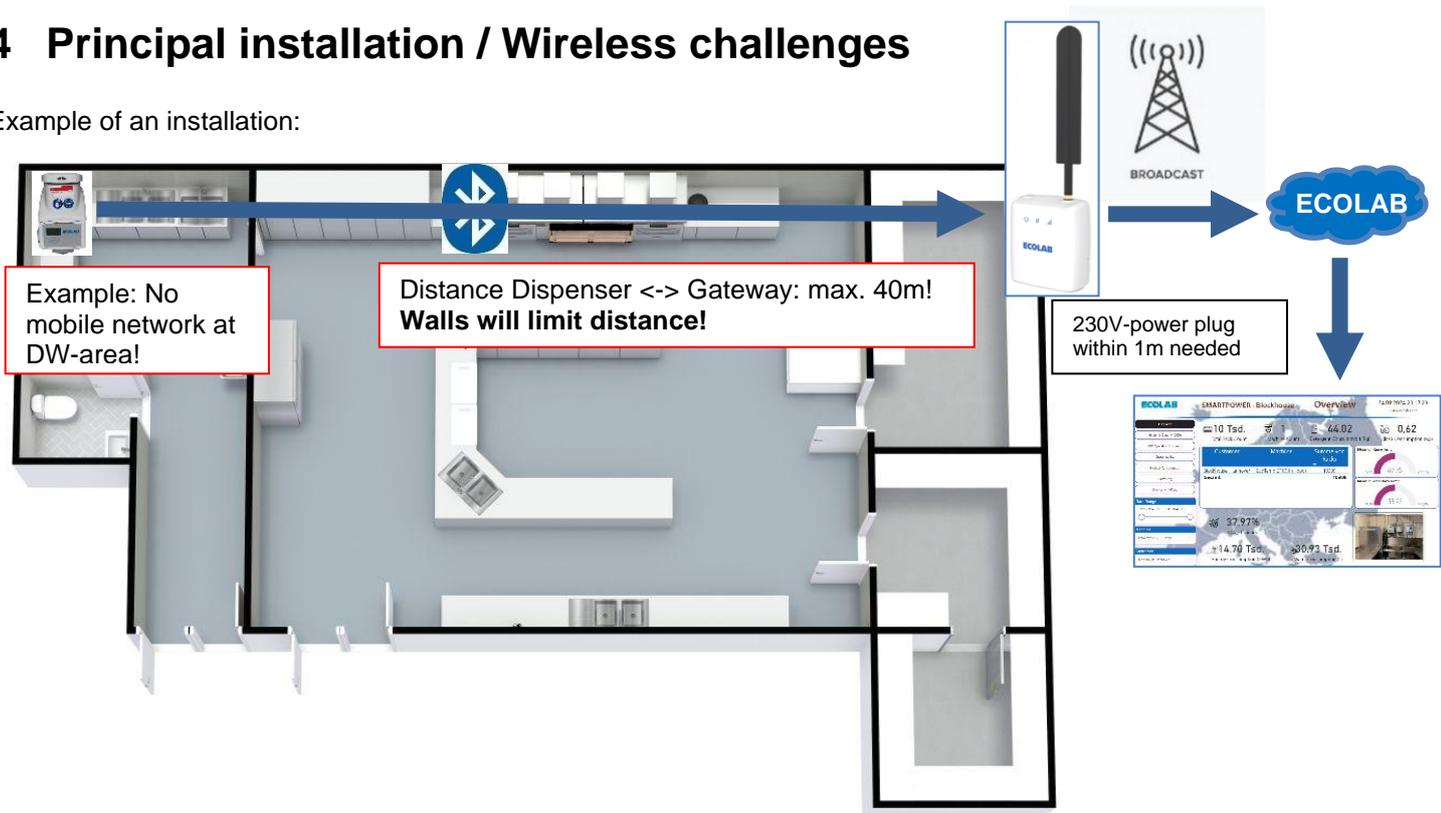
### 4 Principal installation / Wireless challenges

Example of an installation:

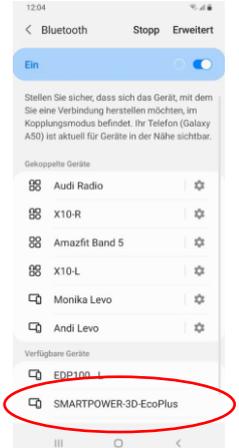
#	At Android devices	At iPhone
1	Switch on dosing unit (only the unit where the connectivity should be tested) This unit sends a Bluetooth signal	
2	Go to the Gateway position	
3	<p>Open the Bluetooth-connection at the mobile device (long press to BT-symbol) ⇒ SMARTPOWER-3D-ECOPLUS appears.</p>

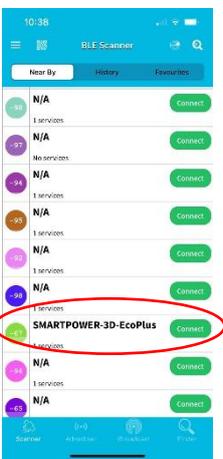
<p><b>NOTE:</b> Install an appropriate Bluetooth-sniffer app (e. g. BLE-Scanner 4.0). Start the App ⇒ SMARTPOWER-3D-ECOPLUS appears.</p>

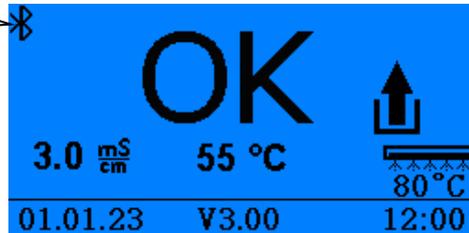
### 7.1 Standard display

If BT-module is connected the "📶" will be shown.

- Will the commissioning be done with an appropriate APP (e. G. ESA-APP) "📶" will appear – the "L" shows that the system is linked to the cloud.

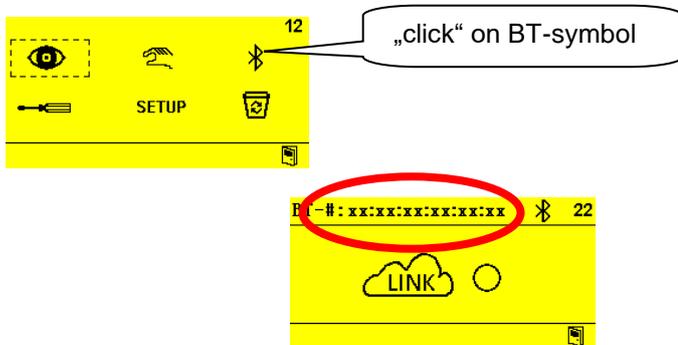
### 8.2 BlueTooth-address

You will find the BT-# in display 22 of WWC-PCB

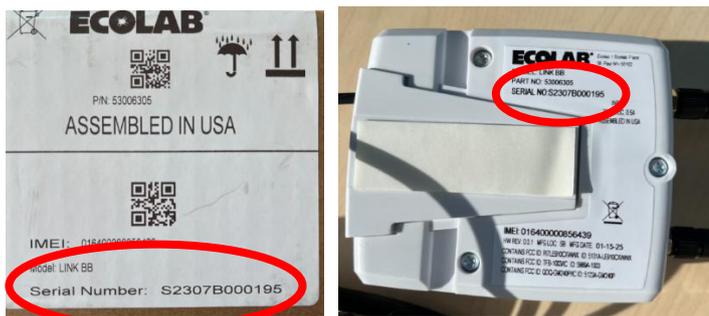
### 8.3 Gateway serial-number

The Gateways must be moved into our EcoPlus – IOT-hub.  
The serial number can be found on the packaging and on the Gateway itself.

The serial number you can find on the back side
